# Pioneer Mills, part 1

*September 2017*

## Pioneer Mills, Part 2

November 2017

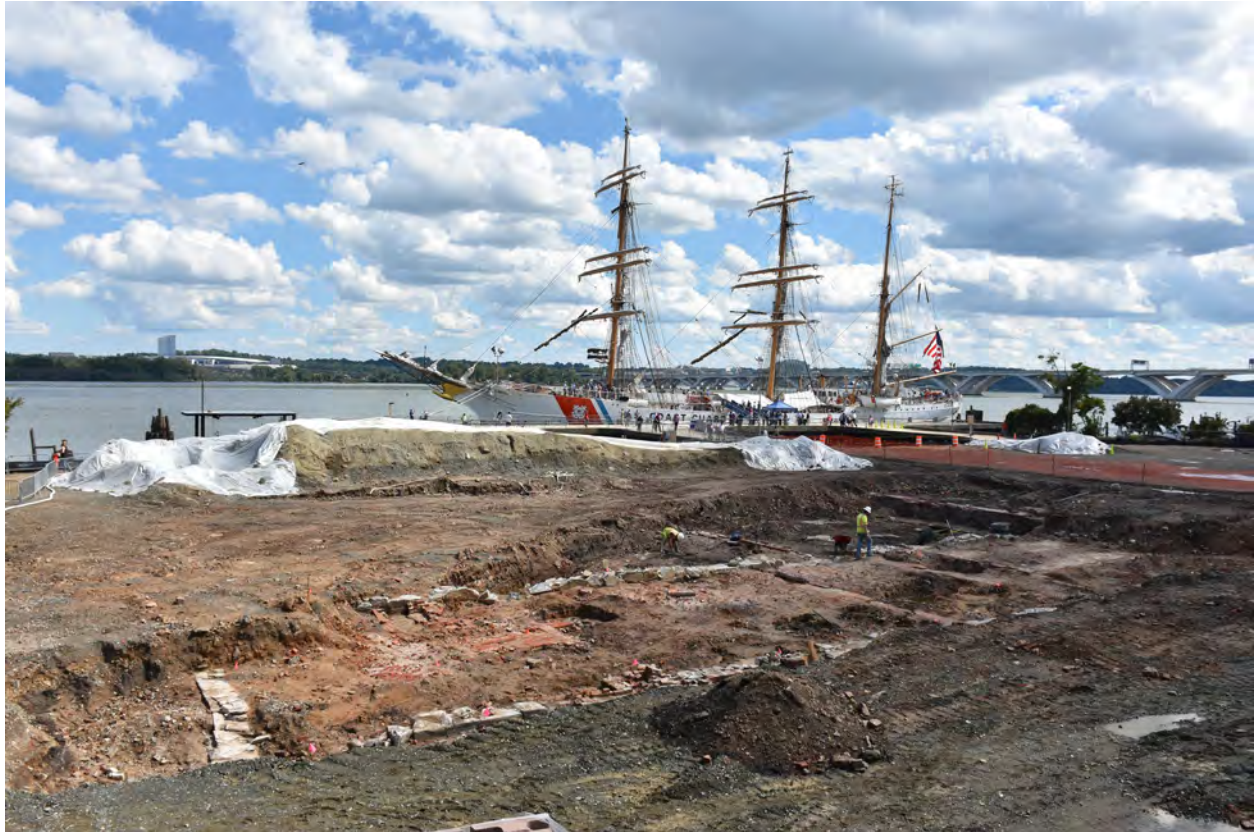
Archaeologists from Thunderbird Archeology are now excavating to the east of the building at 2 Duke Street. There, they are beginning to uncover the imposing remains of Pioneer Mills.

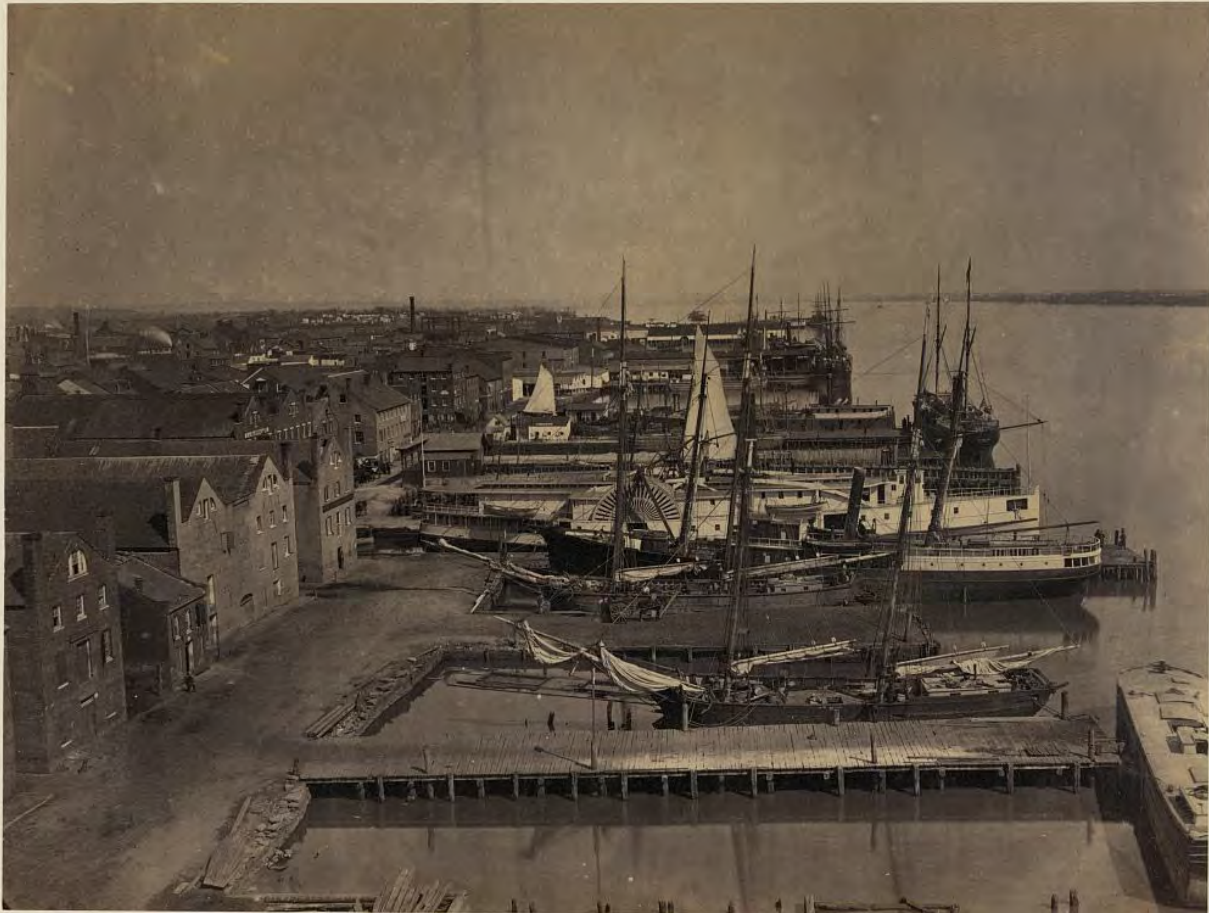
Built in 1854, Pioneer Mills was six stories tall, made of brick, stone, and slate, and dominated the Alexandria waterfront for more than 50 years until it was destroyed by fire in 1897. One of the most iconic 19th-century photographs of the waterfront, seen here, was taken from the top of Pioneer Mills looking north up the waterfront.

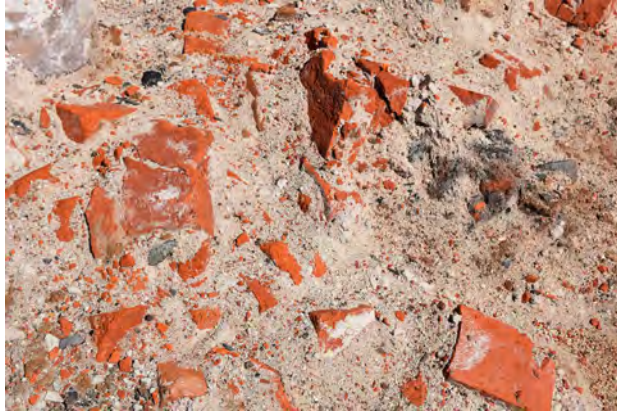
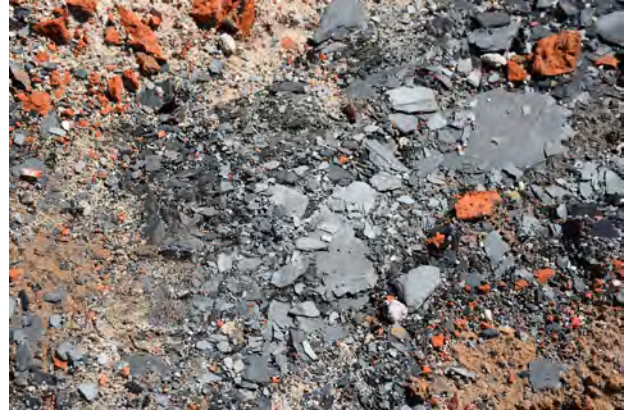
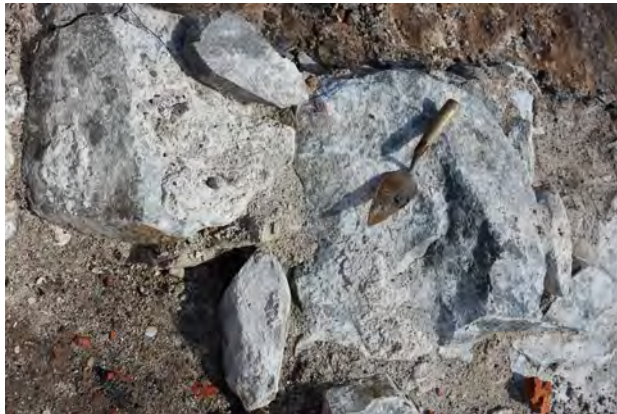
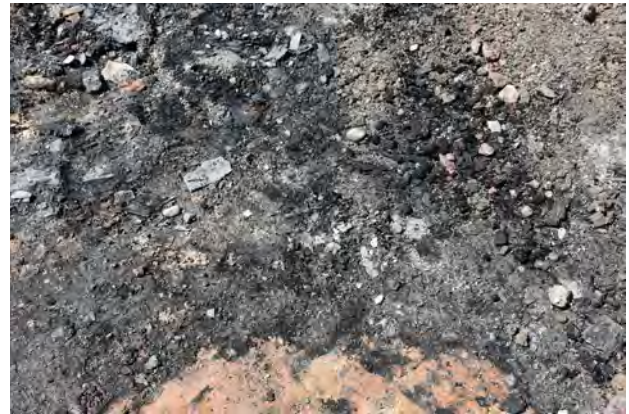
In order to expose the mill's foundations, archaeologists must first dig through layers of rubble related to the destruction of this structure. Pictured here are pockets of brick, stone, and slate debris, all of which were used to build Pioneer Mills, as well as the burn layer related to the 1897 fire.

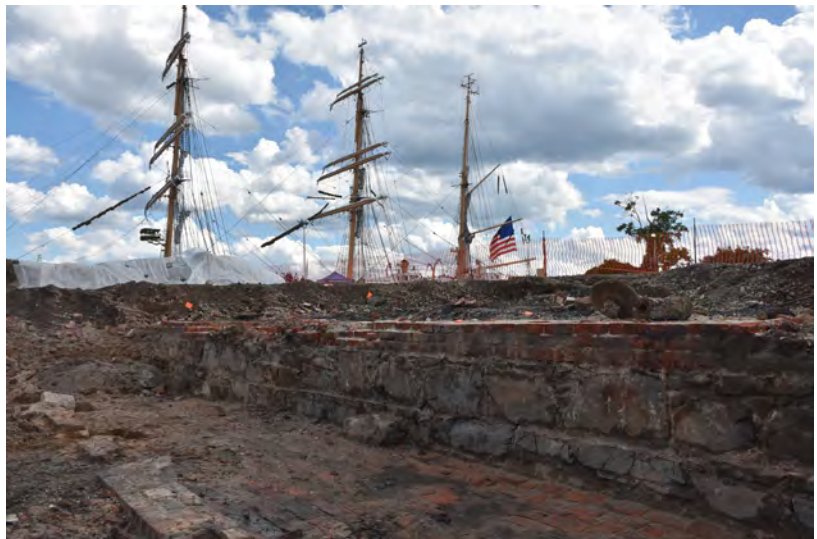
Here is an exposed section of the mill wall and floor with the USCGC Eagle in the background. Note the robust stone foundations with brick walls above as well as the worn brick floor. The walls needed to be thick in order to support the massive brick building above as well as the weight of the grain and machinery inside.

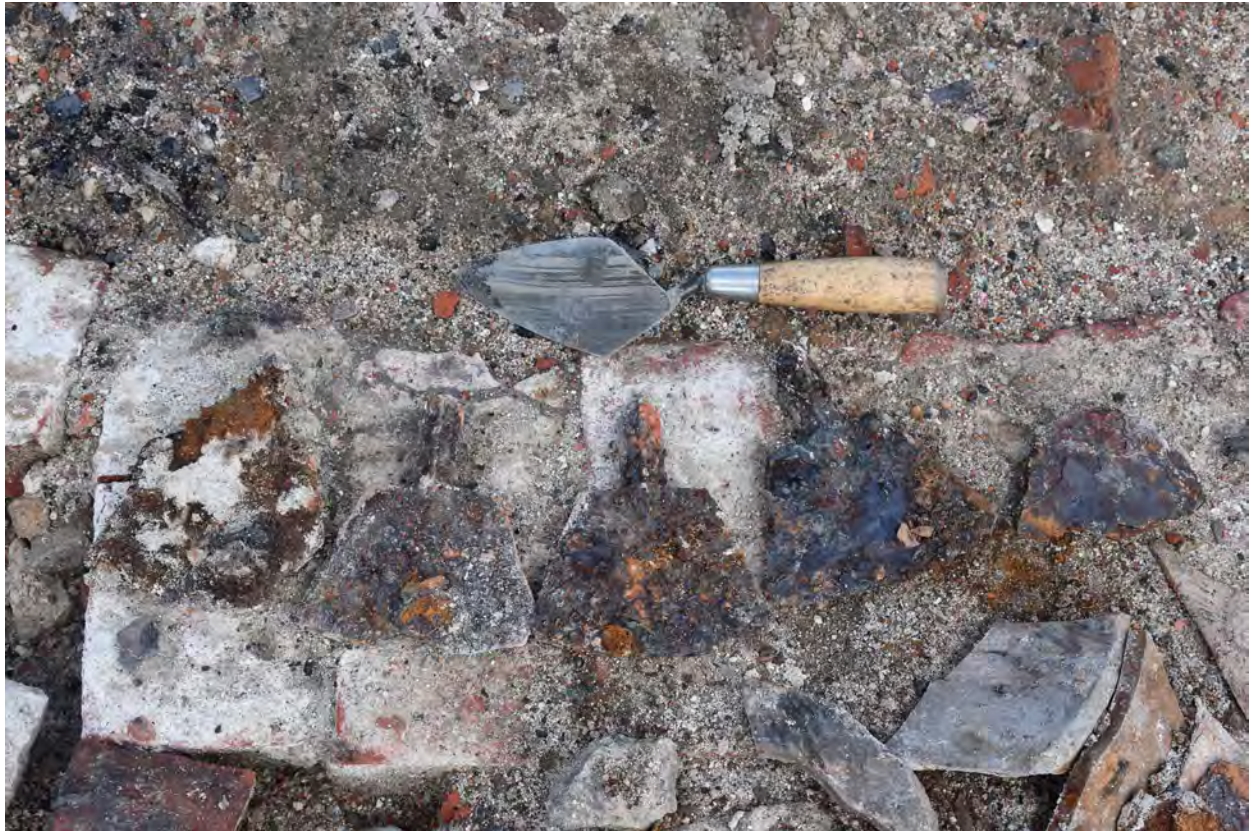
While exposing the mill's foundations and floor, archaeologists also uncovered several of these iron tools whose purpose is not immediately clear. Additional research into the workings of the steam mill or the later manufacturing operations may tell us what these were used for.

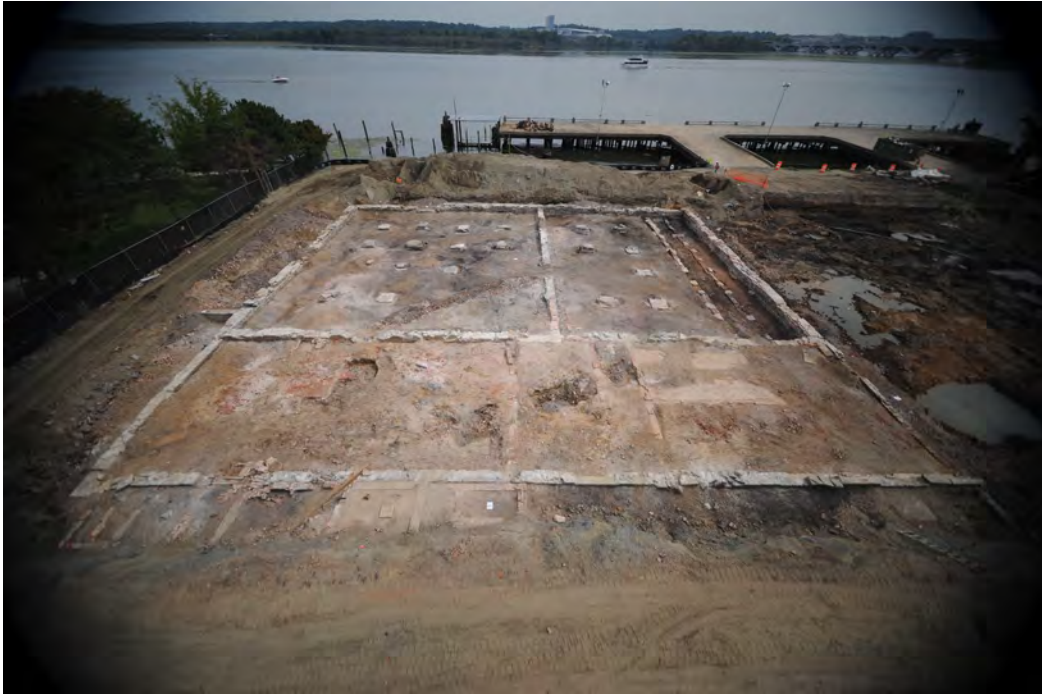
The remains of Pioneer Mills have been fully uncovered and archaeologists are at work documenting the foundations and carefully disassembling the ruin. The mill's foundations measure 122' x 112' and in some places are more than 6' deep. This photo was taken next to the building at 2 Duke Street, looking east toward the Potomac River.

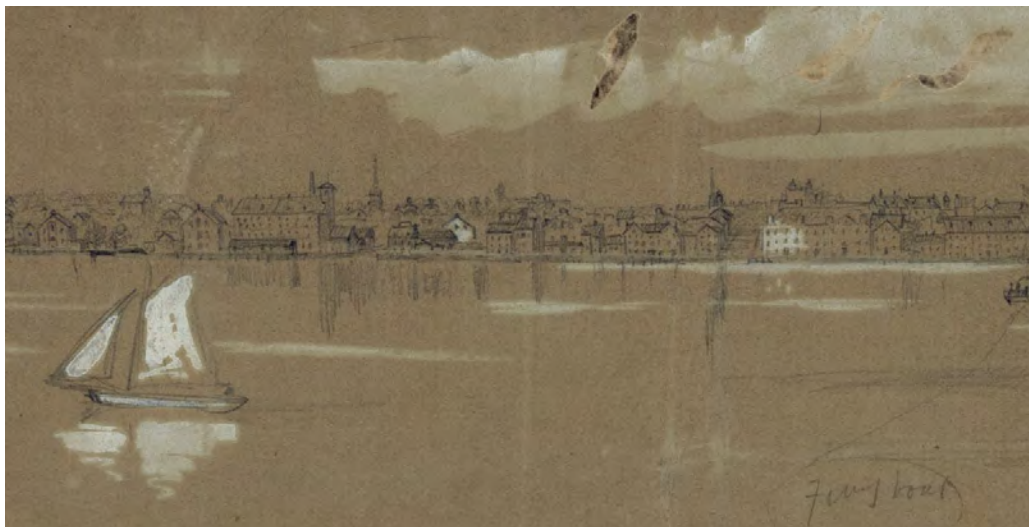
Pioneer Mills can be seen just above and to the right of the sailboat in this detail of an 1861 sketch by *New York Illustrated News* special artist Alfred Waud. Drawings like this one and historic photographs of the mill building can help us better understand some of the archaeological and architectural features being uncovered here at Robinson Landing.

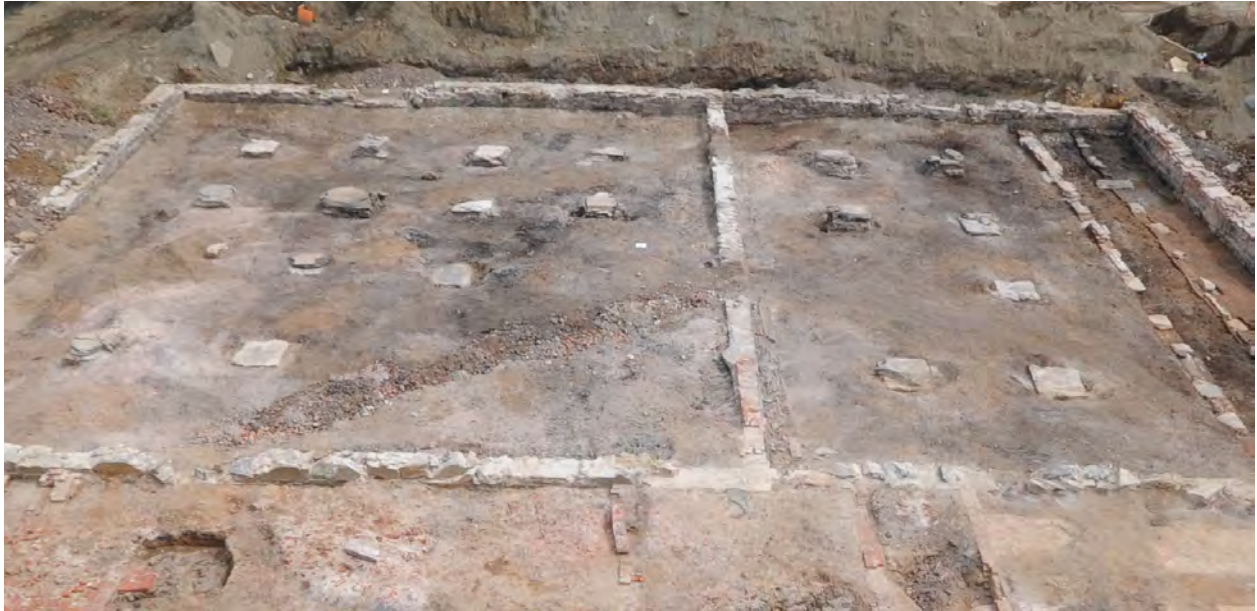
## Stone support piers

These larger, regularly-spaced flat stones in the center of the mill are actually just the tops of stone piers that extend several feet underground. On top of these piers would have sat vertical wooden posts that would have carried the weight of the heavy mill, including its 12 pairs of millstones, machinery, barrels and sacks of flour and wheat, interior floors and walls, and slate roof.

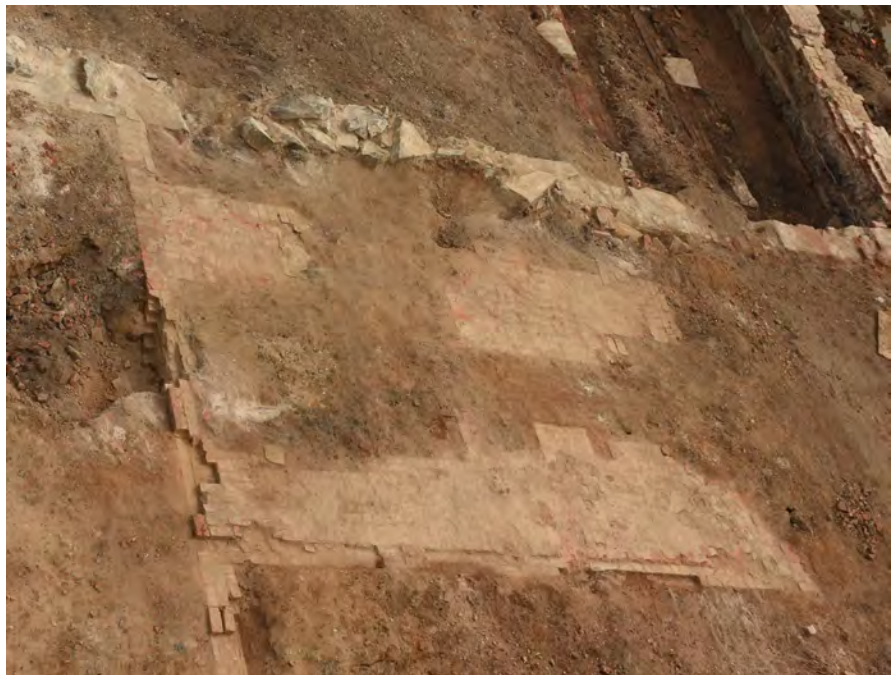
## Brick engine pad and wheel pit

This large, heavy brick feature probably supported the mill's locally-made Smith and Perkins steam engine. While only barely uncovered in this photograph, additional excavations have revealed a slot or trench in the center of this brick pad that would have housed the engine main wheel, which would have been connected to a large shaft that would have supplied the rest of the mill with power through a series of wheels and belts.

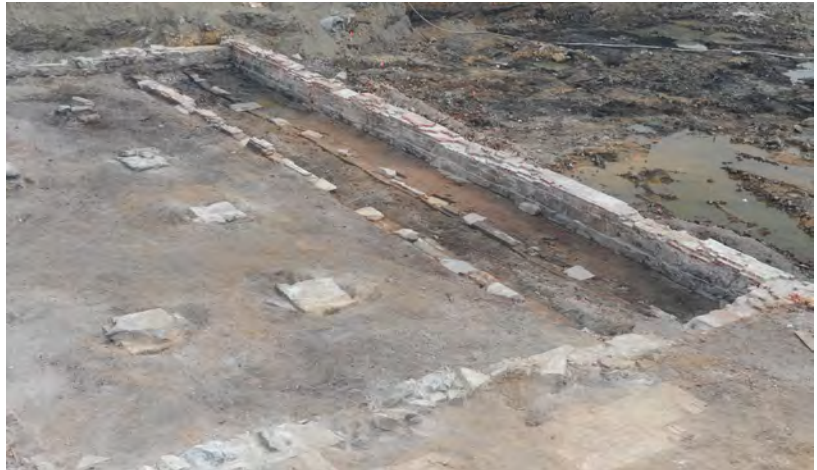
## Small support piers

One interpretation of these two parallel rows of flat stones and narrow channel leading away from the wheel pit is that they could have supported this rotating shaft. Belts would have connected this shaft to each of the pairs of mill stones as well as any other mechanical equipment in the mill such as hoists, lifts, and baggers.

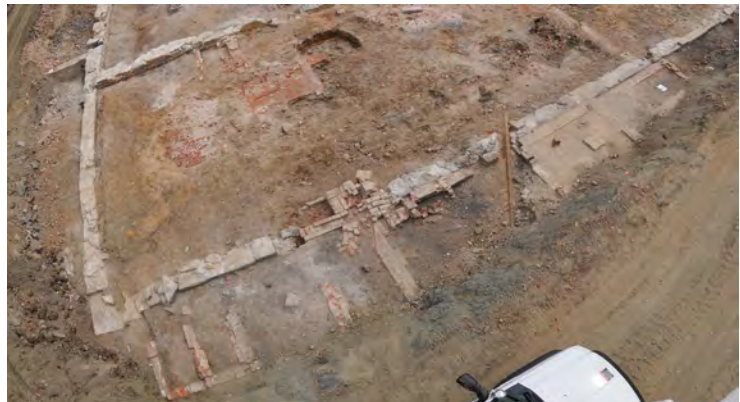
## Additions

The smaller brick rooms seen along the northern and western edges of the mill structure (here along the left and bottom of this photograph) are early-20<sup>th</sup> century additions to the mill. Added sometime between 1912 and 1921, they were used by the Safety First Manufacturing Company as a cleaning room, a core room (for storage of metal casting supplies?), and an office.

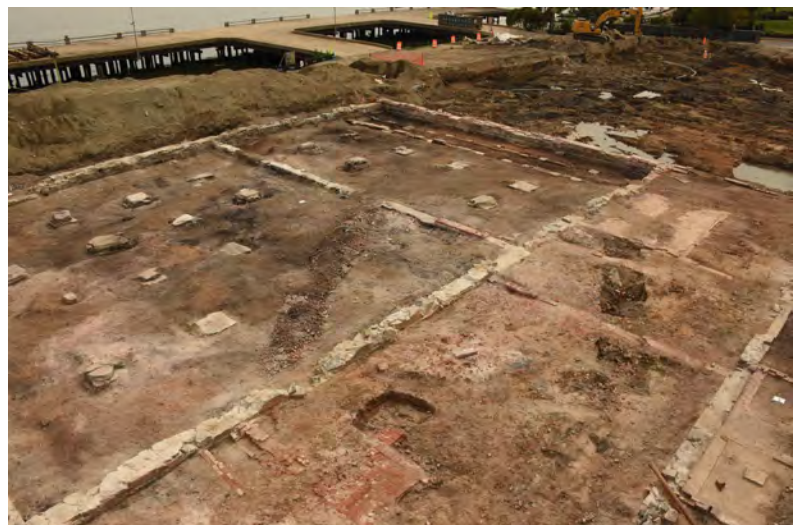
## Archaeology

Sharp-eyed observers will also note these two darker, parallel features cutting diagonally across the mill site (running up and down in the center of this photo). These are back-filled archaeology trenches originally opened in the summer to confirm the mill's location prior to uncovering it.

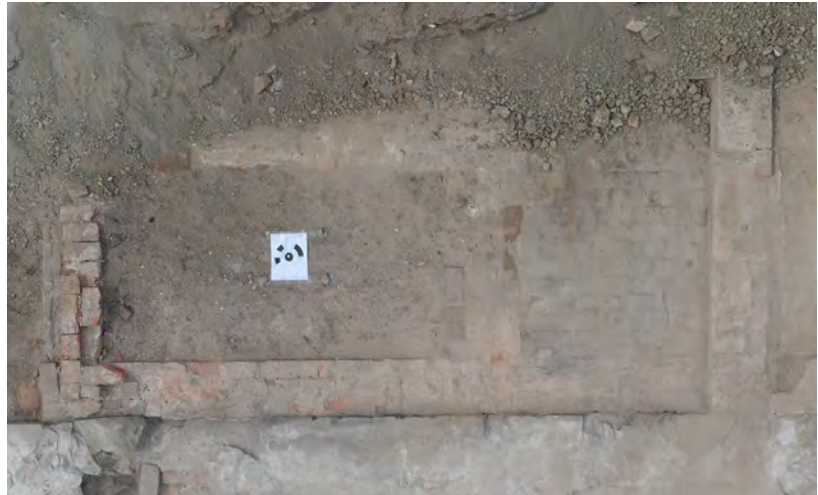
## Photogrammetry

The strange black and white pattern seen here is actually a photogrammetry target. Photogrammetry is a technique that uses many, overlapping images of the same subject in order to create a three dimensional model of that object. If you look closely at the other photos of the mill here, you can see several more of them placed strategically across the mill foundations. These targets are similar to each other, but not identical.

The differences in the patterns help aid archaeologists from Thunderbird Archeology to align over 2000 photographs of the ruins in order to create a photogrammetric model.

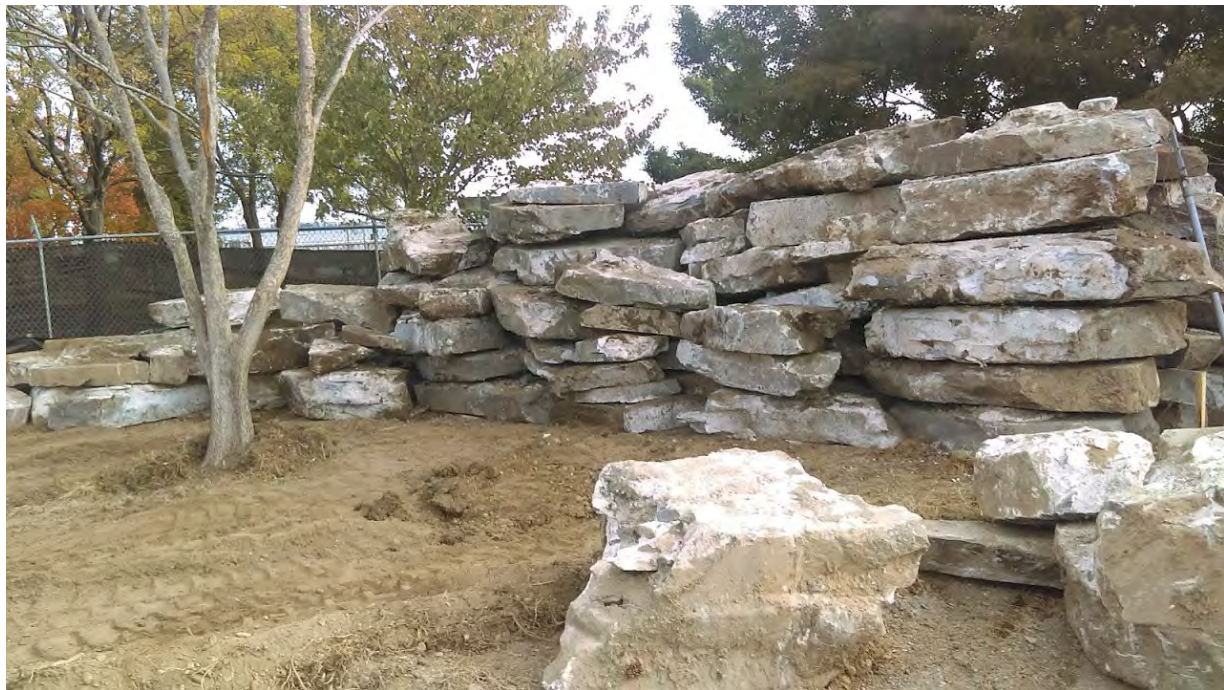
## Excavated foundation stones

After careful documentation and excavation, archaeologists are removing and stacking the Pioneer Mills foundation stones for potential reuse in future projects.
