Re: Management Summary for City of Alexandria Fort Ward Park Archaeological Monitoring

New South Associates, Inc. (NSA) has completed archaeological monitoring for access improvements at the Fort Ward Park picnic pavilion (Figure 1). Erin Cagney, MA, RPA conducted the monitoring between April 29th and June 23rd, 2022.

Re: Addendum to the Management Summary for City of Alexandria Fort Ward Park Archaeological Monitoring for additional excavation of angled parking space

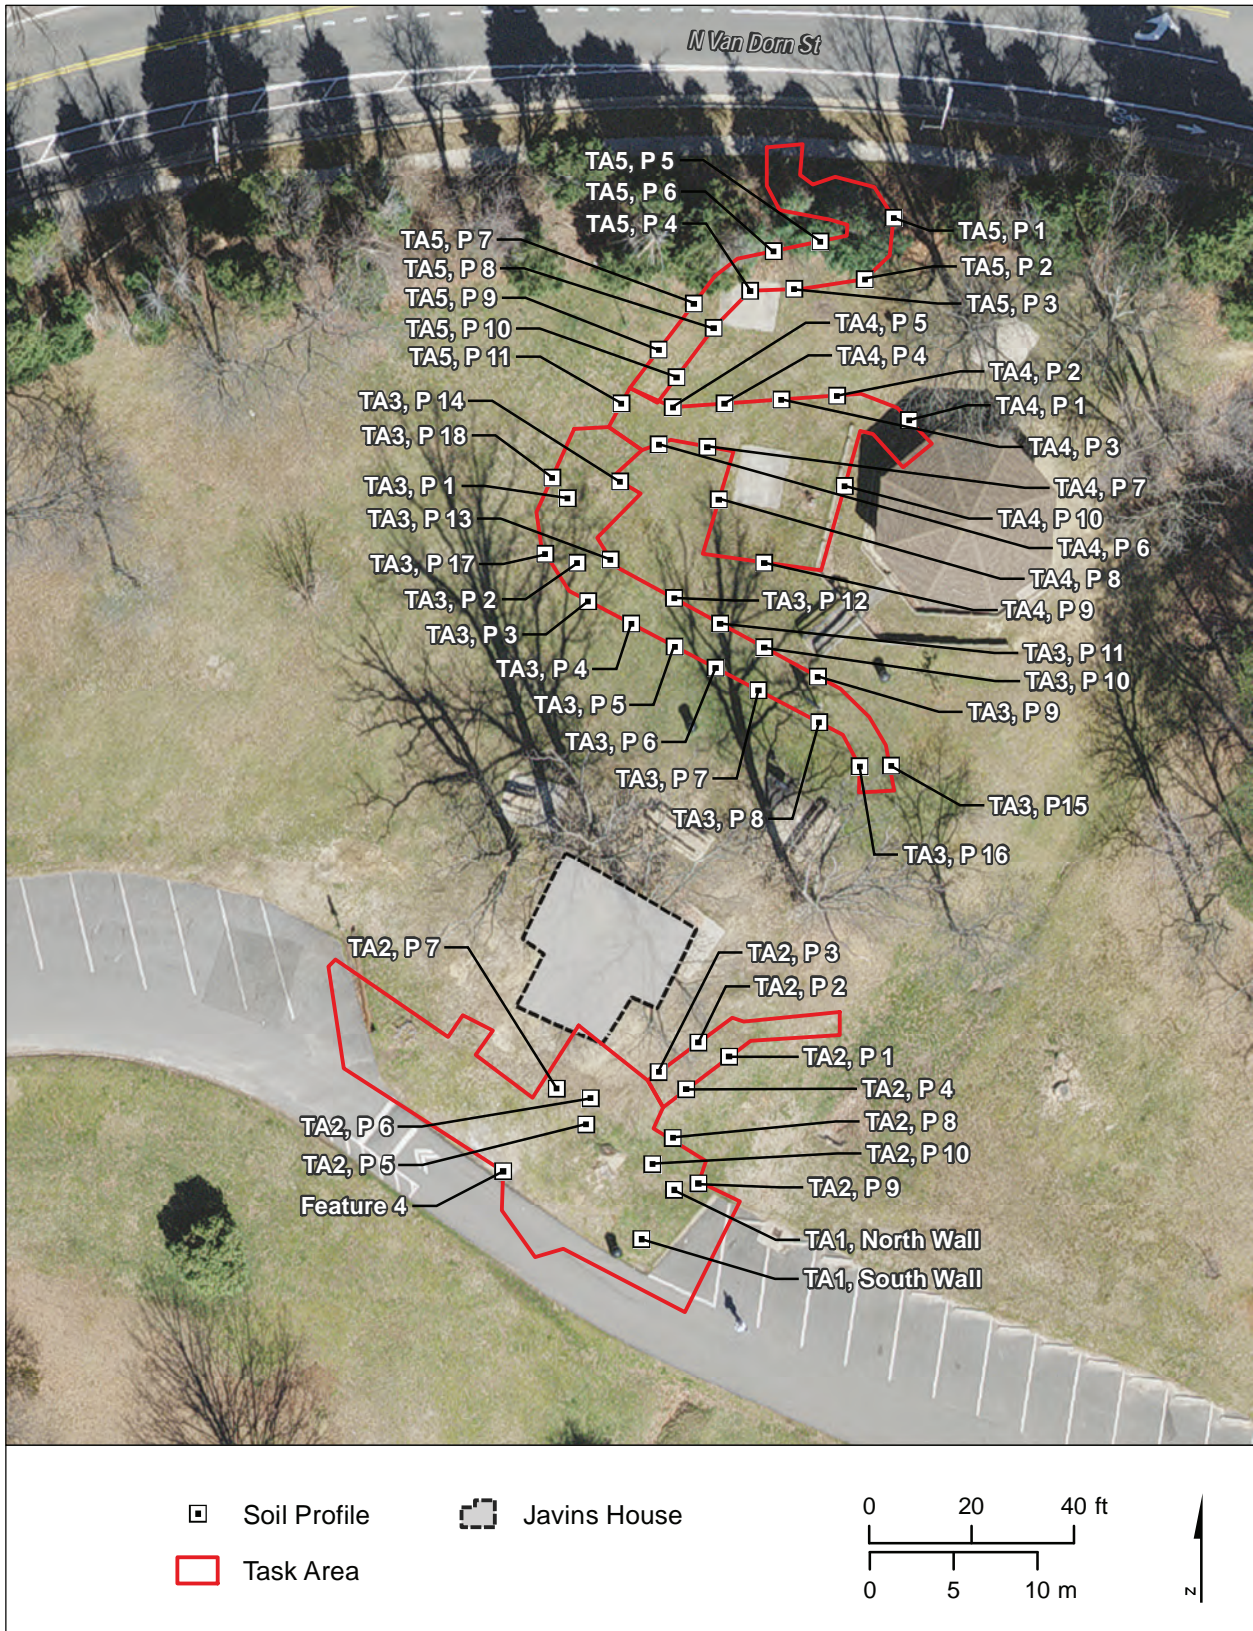
Figure 4.
 Projected Javins House Location, Task Areas, and Soil Profiles

The work was divided into five Task Areas (Task Areas 1-5) as defined by the Scope of Work (SOW) (Figure 3). Monitoring tasks were further defined by the extent of excavation (grading vs. trenching), which were delineated on a color-coded schematic provided by Alexandria Archaeology (See Figure 3). In red areas, the monitor directed the backhoe to excavate to the top of subsoil in 10-foot sections. The monitor then cleaned the area with a shovel and/or trowel to observe any subsurface features. Profile drawings were made of one-foot columns every 10 feet in all cardinal directions. In orange areas, the monitor observed the extent of excavation, cleaned the area with a shovel, and recorded soil profiles of one-foot columns in all cardinal directions. Profiles were labeled by area and assigned a unique number (i.e., Task Area 5, Profile #1). The approximate location of each profile drawing is shown in Figure 4.

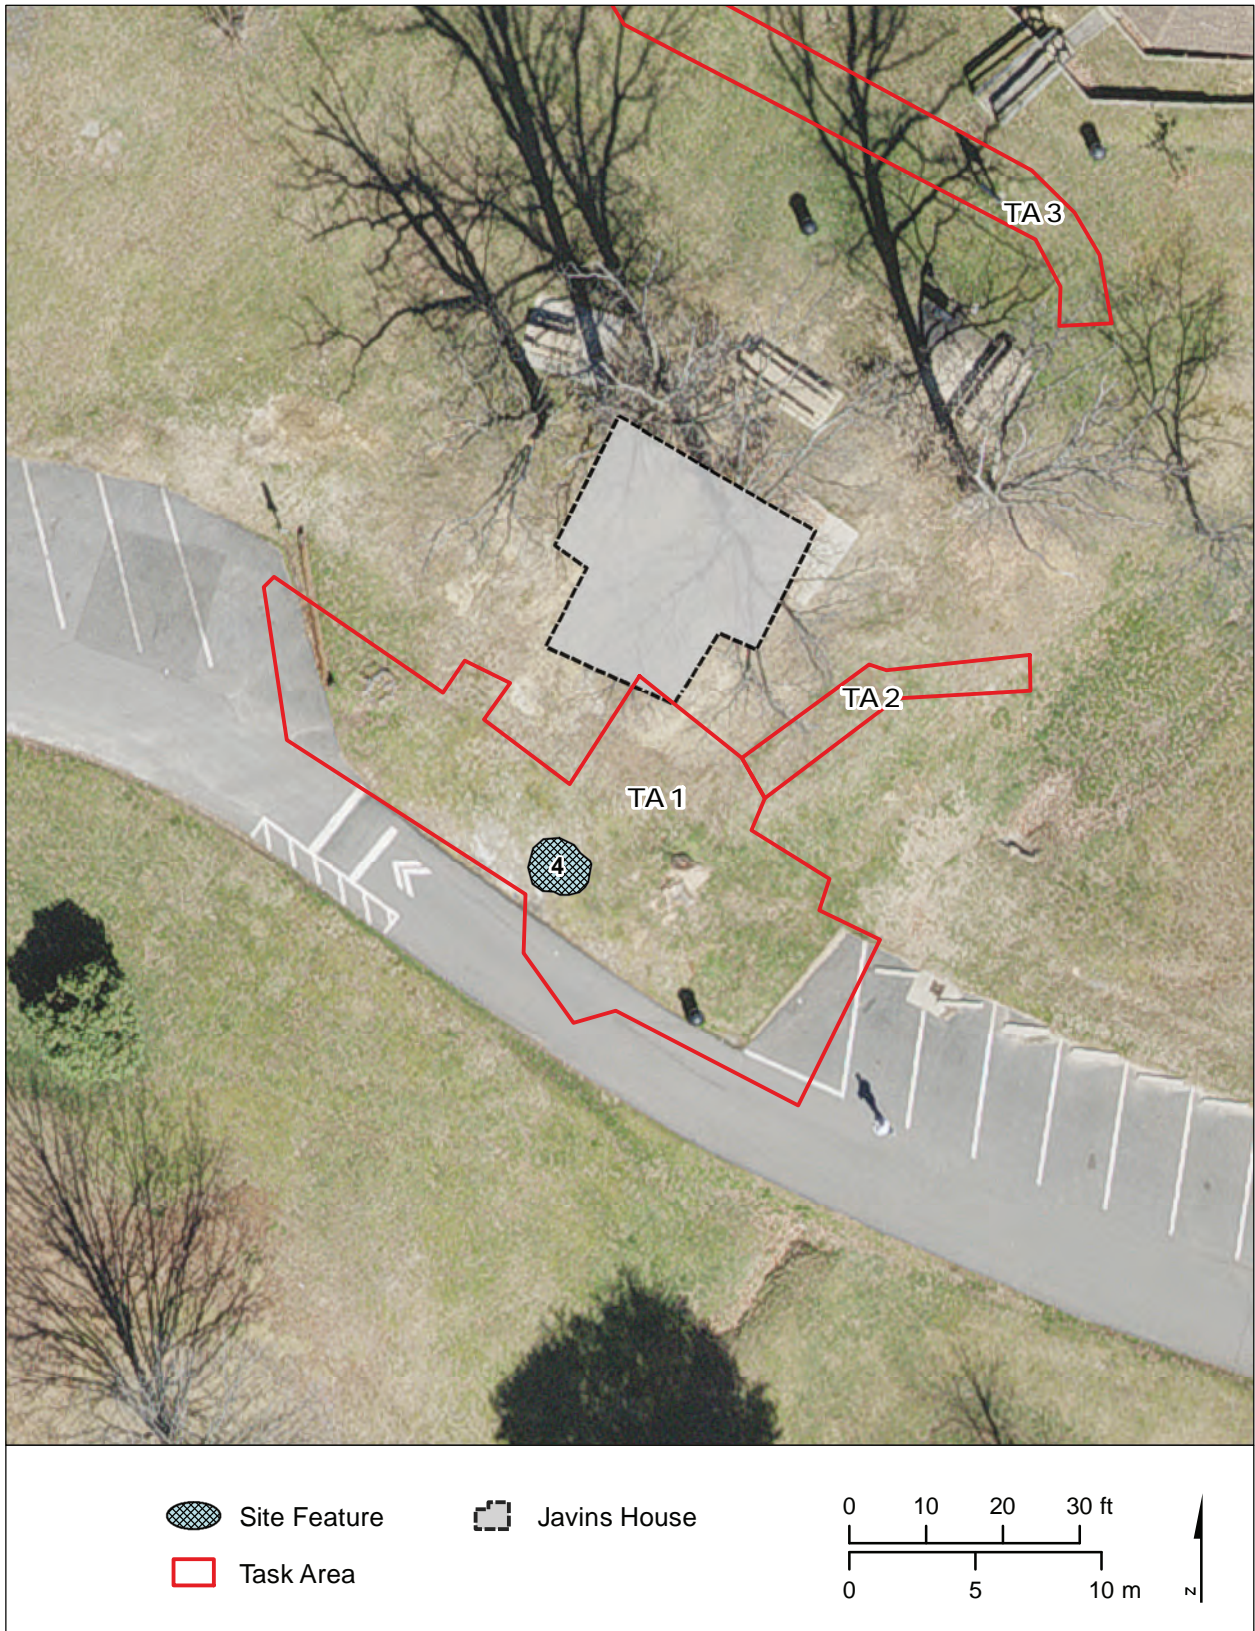
Figure 5.
Location of Feature 4, Possible Well at Site 44AX90, Javins House

NSA identified one subsurface feature related to the Javins occupation, which was a deep pit identified as a possible well in Task Area 1 (Feature 4; Figure 5). Across the rest of the monitoring areas, artifacts were sparse. All artifacts were recovered in the Ap horizon, which appeared at various depths across the site, ranging from the surface to one foot below the ground surface (bgs). They included whiteware, ironstone, a cut nail, and vessel glass fragments. Soil disturbance was noted in various parts of the site, including the portion of Task Area 5 near Van Dorn Street, Task Area 4 near the picnic pavilion, and Task Area 3 between the picnic pavilion and the projected location of the Javins house. The disturbances can likely be attributed to the construction of the picnic pavilion and other recreational use of the site after it became Fort Ward Park.

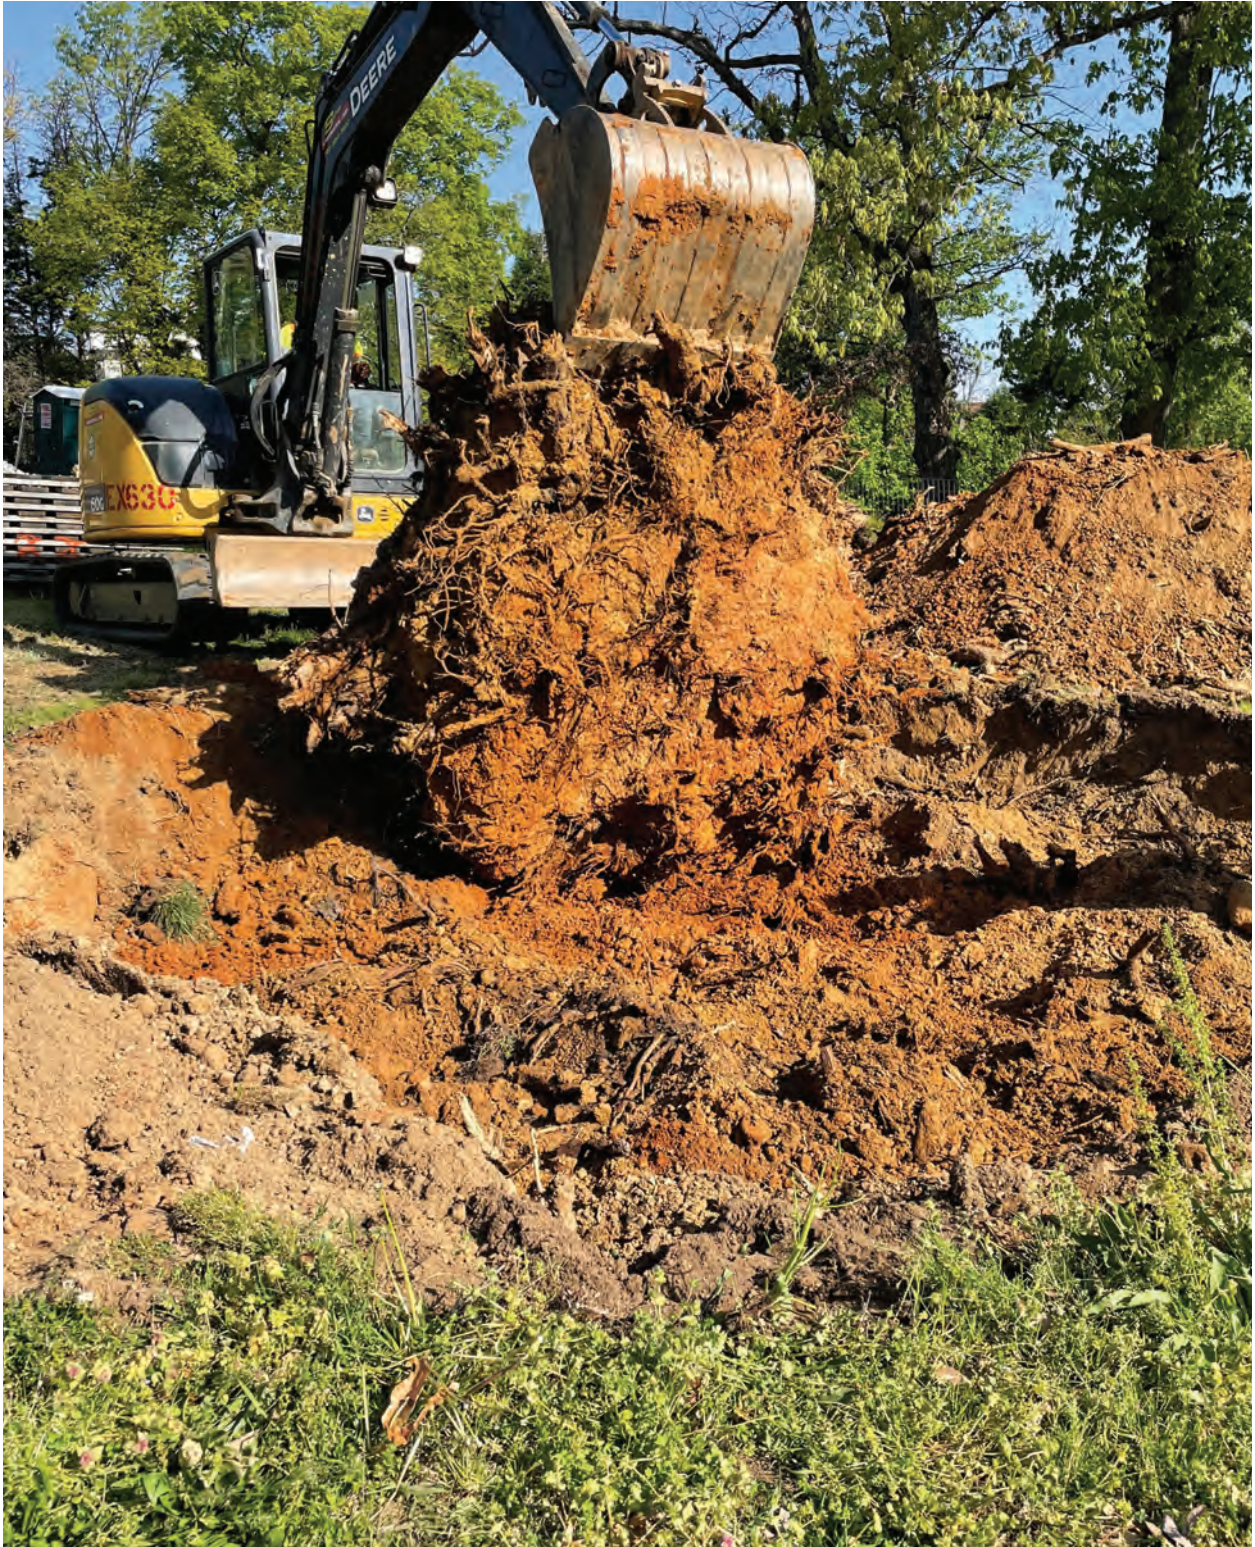
Figure 6.
Task Area 1A, tree stump removal and backhoe stripping, looking Northwest

Task 1A included monitoring the removal of two tree stumps. For the easternmost stump, a large area was excavated around the base. The monitor directed the backhoe operator to excavate only to the top of the subsoil. The area was then cleaned with a shovel and photographed (Figure 6). Soil profiles were drawn of the north and south walls (Figure 7). A total of 10 artifacts that could date to the Javins family were collected from this area. The backhoe operator then removed the stump, replaced soil in the hole, and graded the area to level with the existing pavement (Task 1C). No subsurface features were noted. The westernmost tree was significantly deteriorated, resulting in no adverse effects to the surrounding soils when removed.

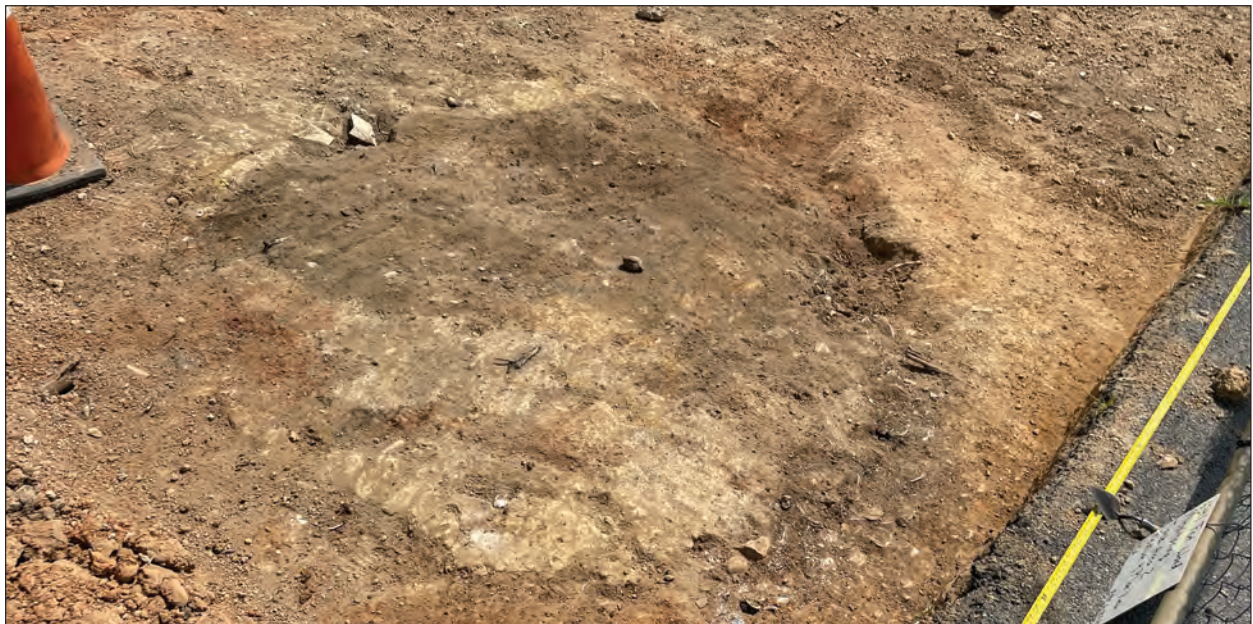
Figure 8.
Plan view of Feature 4, Possible Well, in Task Area 1

Feature 4 was discovered in Task Area 1 after the backhoe excavated between the existing parking areas adjacent to the park access road (Figure 8). The feature was a brown (10YR 4/3), circular soil stain approximately eight feet in diameter with apparent shell concentrations and artifacts visible on the surface. After a site consultation with City Archaeologist Garrett Fesler, feature treatment included trowel cleaning, collection of loose artifacts on the surface, mapping, GPS data collection, and auger testing. A site datum was placed in the southwest corner of the exposed area, and the feature was covered and preserved in place. The construction contractor, Sagres, then proceeded with the work plan to cover the area with gravel substrate and asphalt for parking spaces. A total of 219 artifacts were collected while cleaning the feature, including a Tabasco bottle dating from 1939 – 1959 (Tables 1 and 2; Figure 9). This dates the deposition of the artifacts toward the latter part of the Javins occupation.

A. Plan View Drawing of Feature 4

B. Photograph of Feature 4, facing Northeast

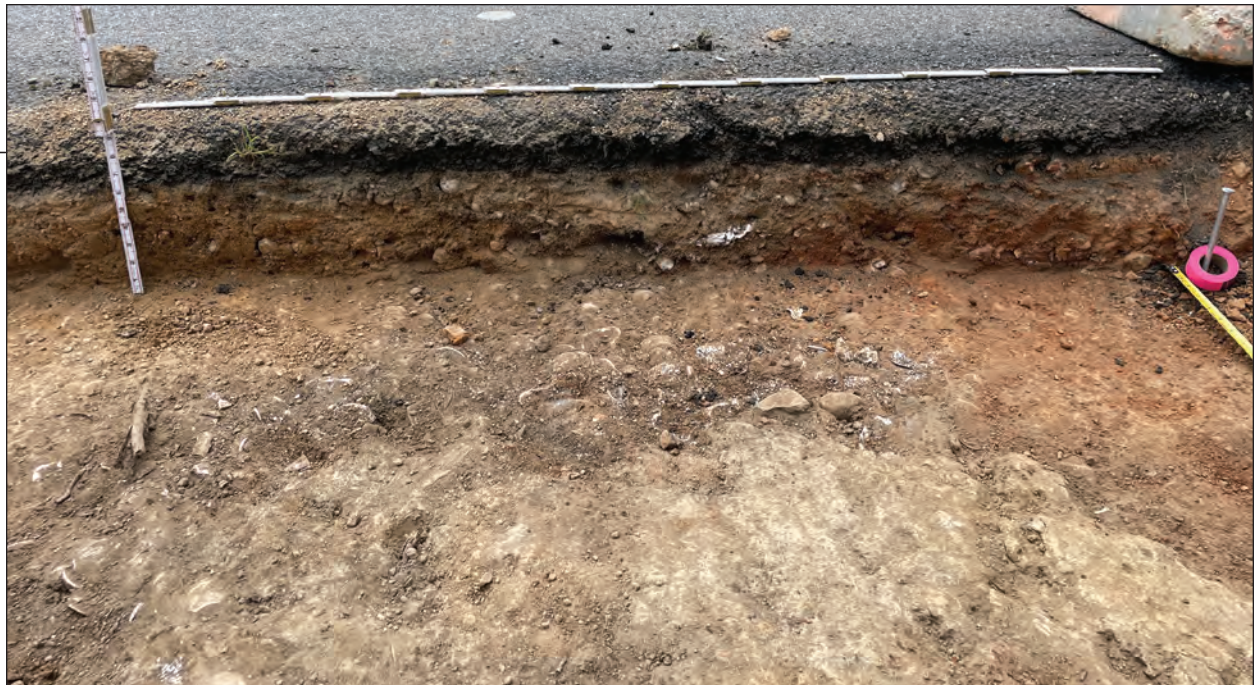
Figure 10.
 South Wall Profile of Task Area 1, Top of Feature 4 Apparent in Wall

The feature was recorded from a depth of 0.9' bgs, as measured from the top of the asphalt, and parts of it appeared in the wall near the original ground surface, immediately below the asphalt (Figure 10). Prior to covering the feature, an auger test was placed directly in the center using a four-inch bucket auger. The auger reached 2.6' below the surface of the feature before refusal by a dense pocket of shell (oyster and clam), which also contained a few shards of glass (Figure 11). Shell samples and artifacts were collected from the auger bucket, and their depth was noted. This feature was initially considered a possible trash pit or burn pit, but the depth of the feature indicates a possible filled in well or privy. This feature was located near the outbuildings apparent on the 1927 aerial of the Javins house and may be related to one of those. Further excavation would be needed to determine the nature of this feature.

A. Profile drawing of South wall of Task Area 1

B. Photograph of South wall of Task Area 1

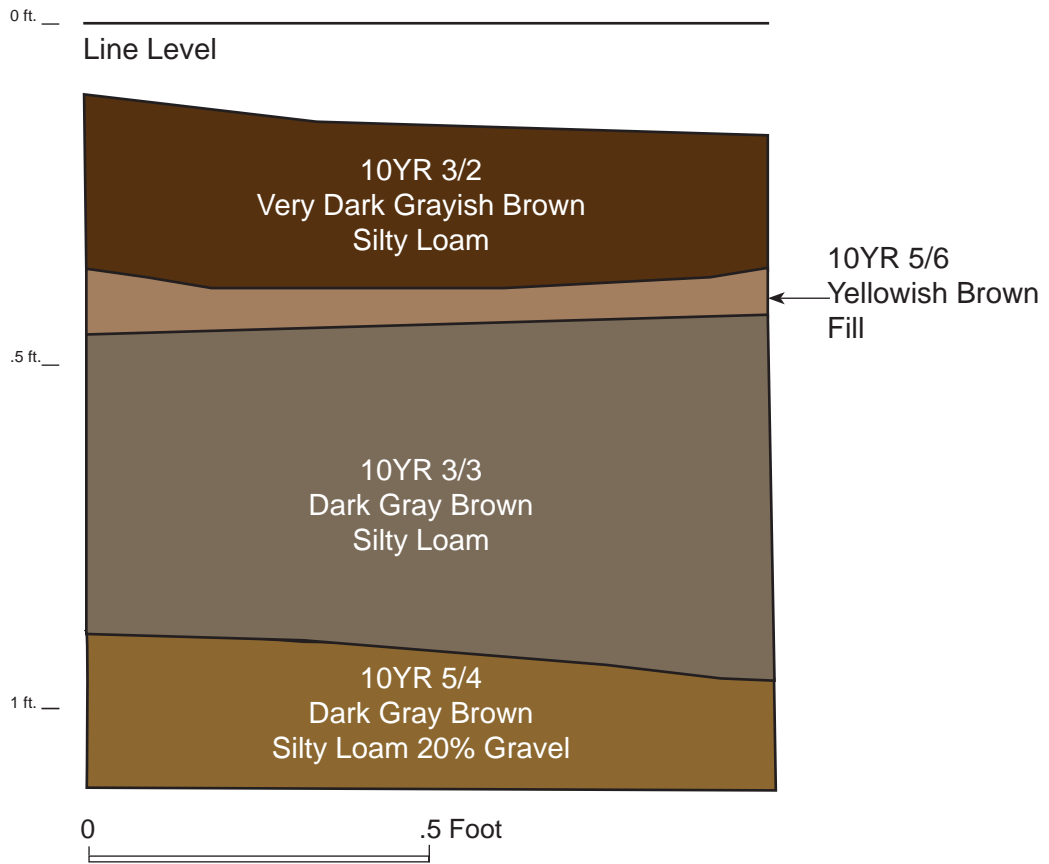
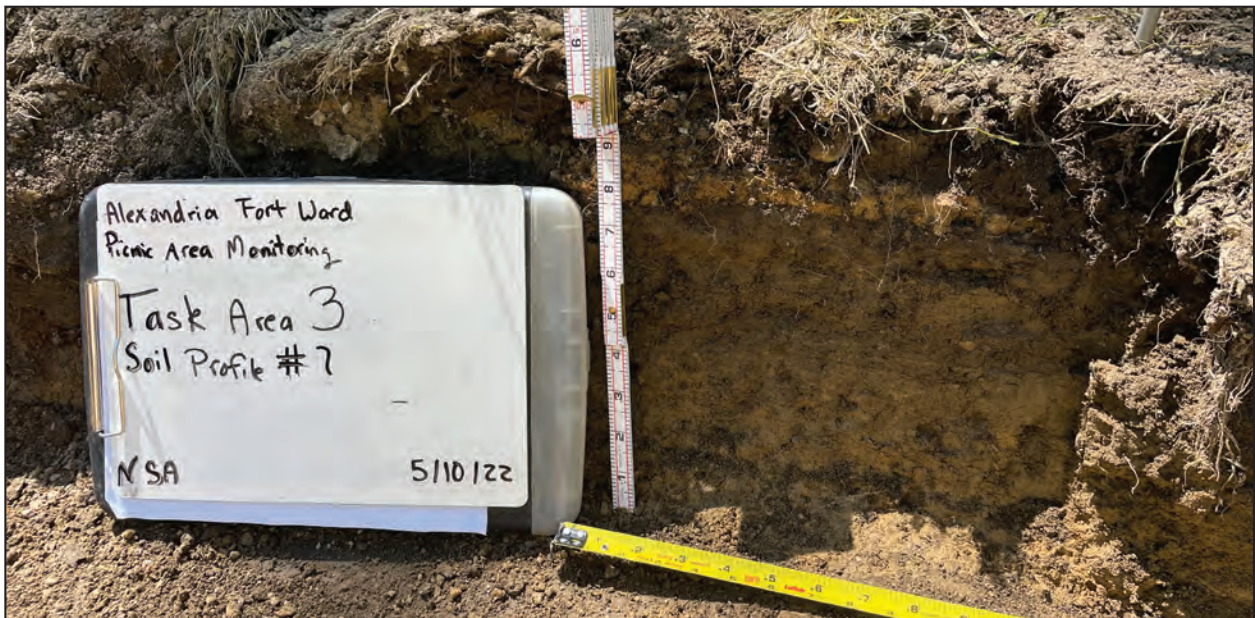
Figure 15.
North Wall Profile of Task Area 3 (Profile #7)

Task Area 3 was in the central portion of the underdrain excavation, running roughly east to west between the picnic pavilion and the projected location of the Javins house. Most of this area was excavated on May 9th and 10th, 2022. An approximately 20-foot area on the east end of Task Area 3 was temporarily left unexcavated to allow for the movement of heavy machinery. Monitoring was then completed on May 25th, 2022. The topsoil (O and A horizons) was relatively thick in this area and was generally undisturbed (Figure 15). Directly south of the picnic pavilion, though, there was evidence of cutting and filling, likely related to the construction of the pavilion and other recreational use. Soil profiles were drawn every 10 feet. No artifacts were collected from Task Area 3, and no subsurface features were noted.

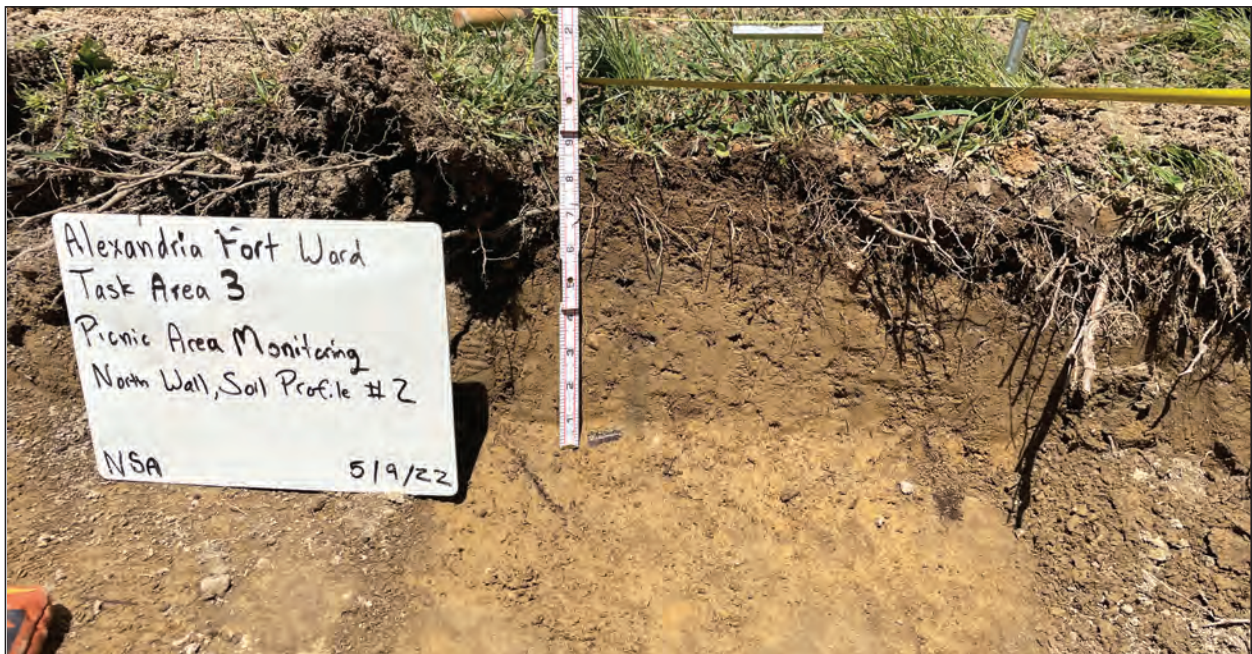
Figure 16.
South Wall Profile of Task Area 4 (Profile #2)

Task Area 4 was adjacent to the west side of the picnic pavilion, connecting the pavilion with the rest of the path to the west. This area was excavated on May 9th, 2022 and included the removal of a concrete pad. Soils immediately adjacent to the picnic pavilion were clearly disturbed and included gravel fill. Moving away from the pavilion to the west, soils generally retained integrity (Figure 16). Some artifacts were noted in the A horizon, approximately 0.8-1.0' bgs. One whiteware sherd was collected, and two glass fragments were noted, but not collected. Profiles were drawn every 10 feet. No subsurface features were noted.

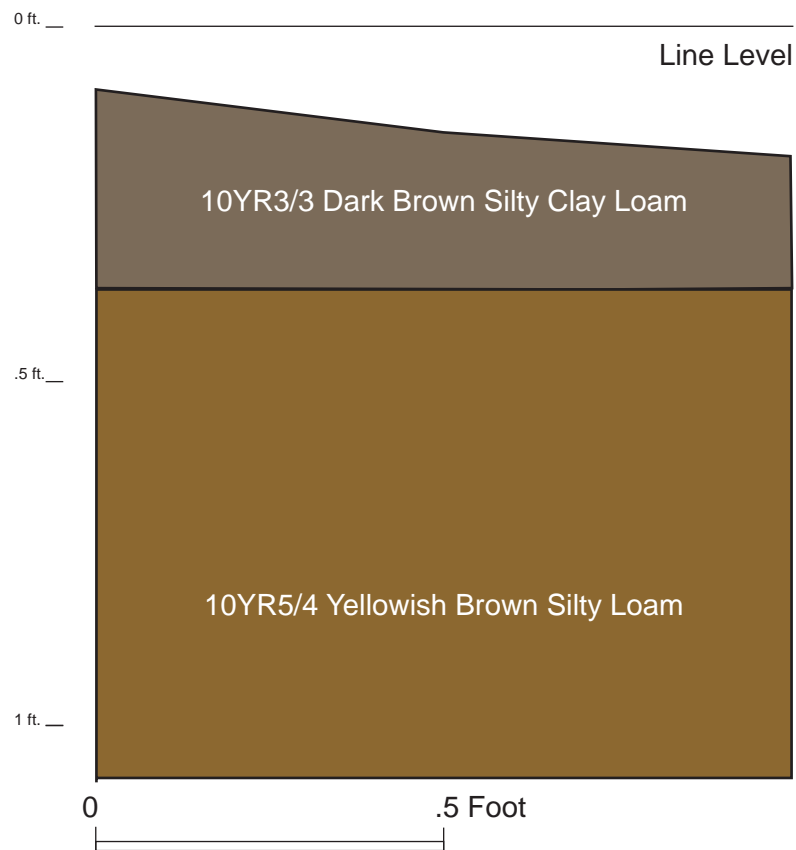
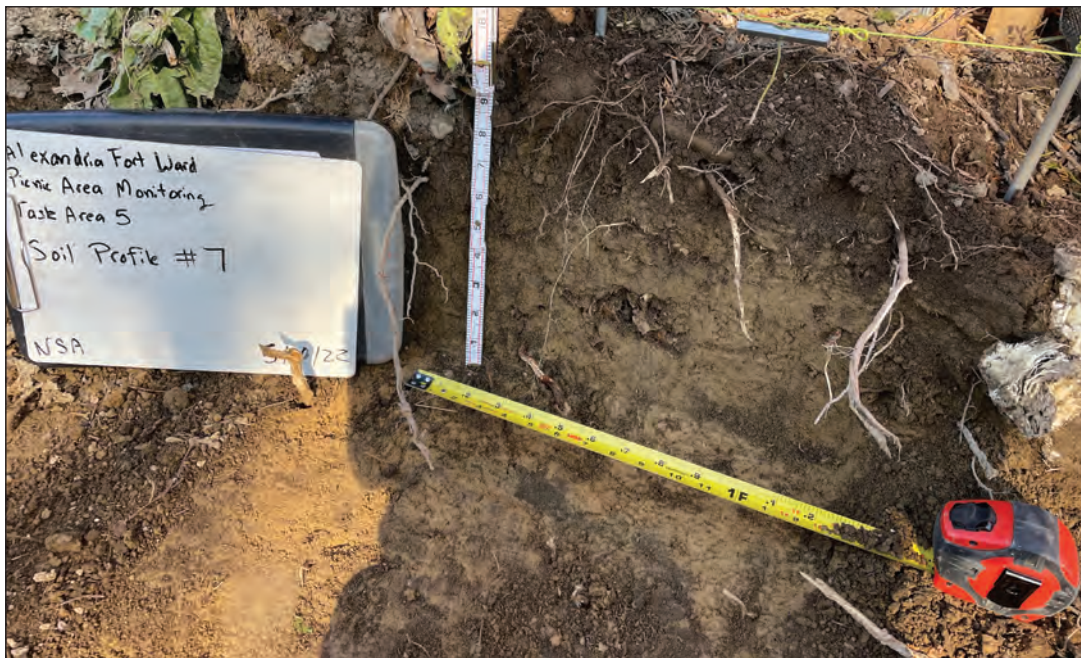
Figure 17.
West Wall Profile of Task Area 5 (Profile #7)

Task Area 5 was adjacent to Van Dorn Street. The planned path included a tight curve before moving southward in a more linear fashion. The "U-shaped" part of Task Area 5 had been wooded prior to construction. Multiple trees with one-to-two-foot trunks had to be removed prior to excavation. This activity was monitored and documented on May 4th, 2022. When the underdrain trench was excavated on May 9th, 2022, much of this area was disturbed from the tree removal activity, heavy rains over the preceding weekend, and the heavy machinery. Excessively disturbed soils were not profiled. No subsurface features were observed. The soil profile was generally very shallow in this area (Figure 17).

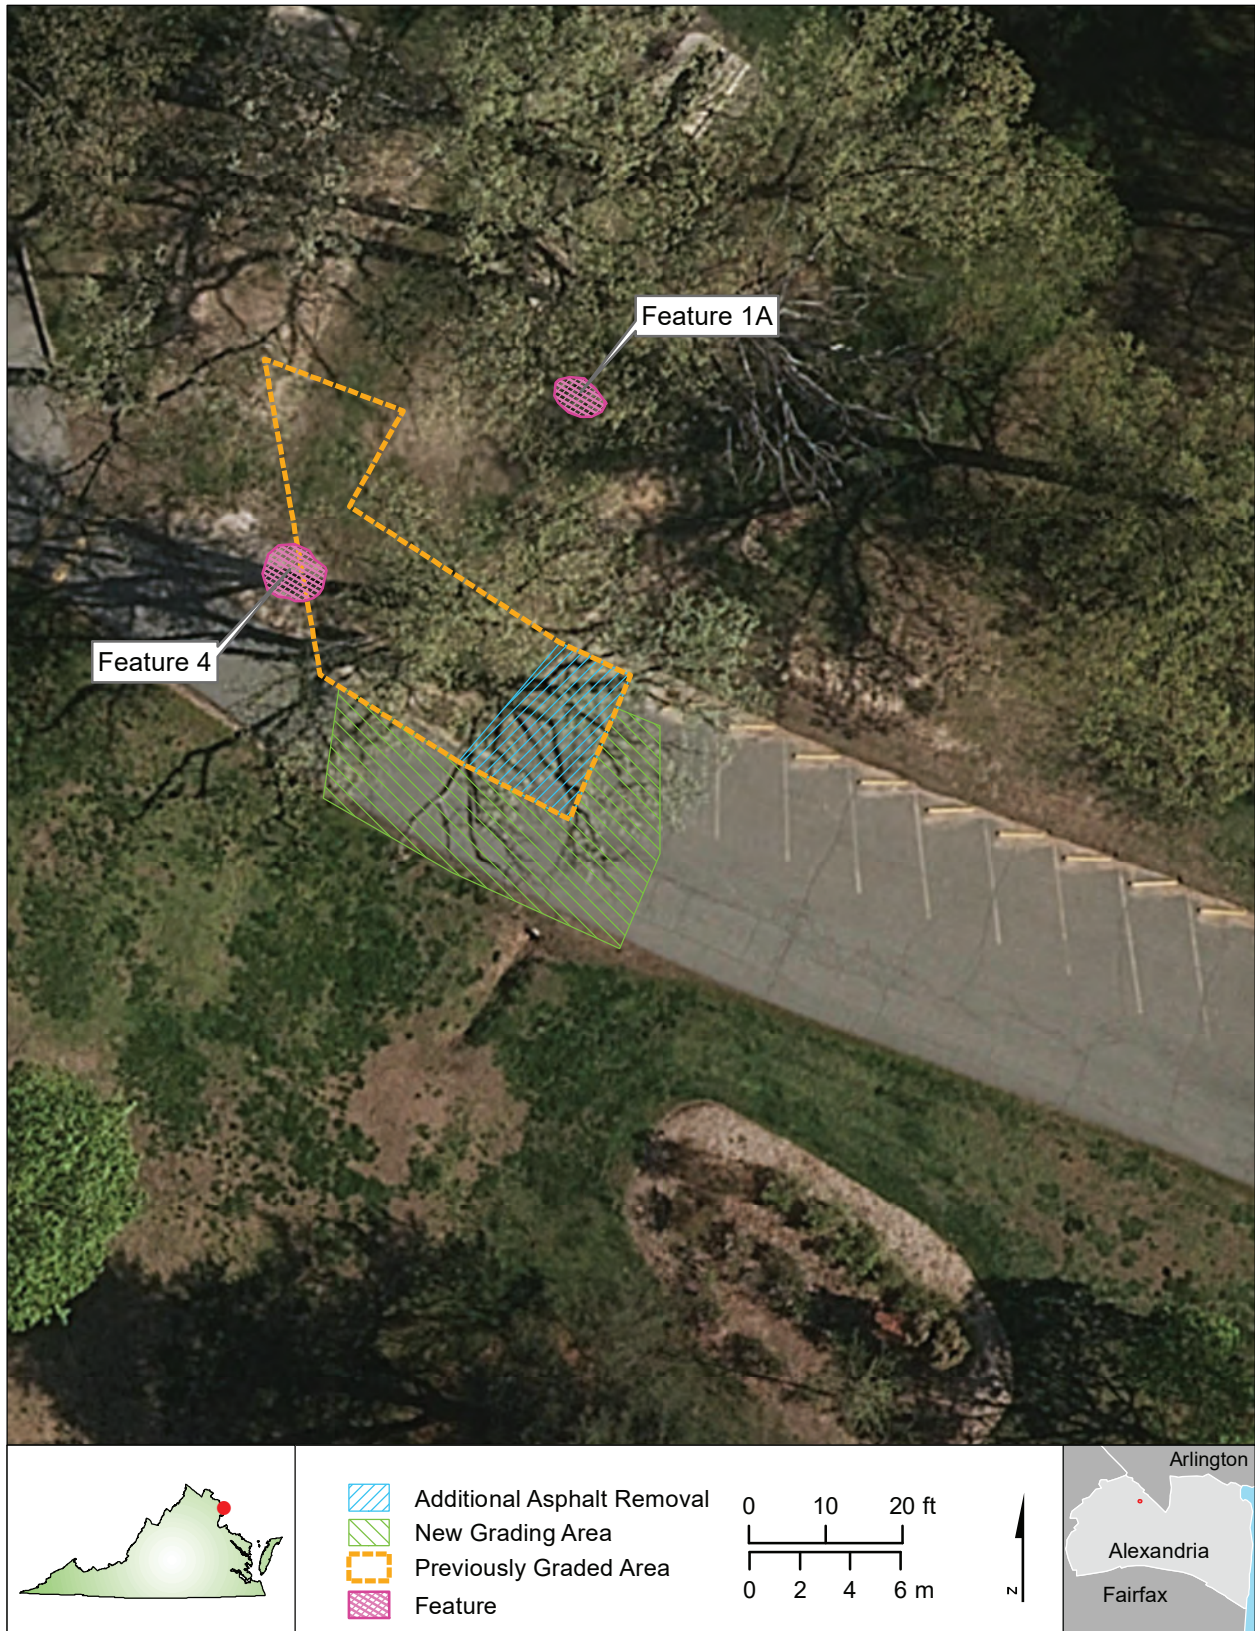
Figure 2.
Map of Grading Areas

Based on the map provided in the Scope of Work, new grading was anticipated for approximately 45 feet along the 14-foot-wide asphalt road. Grading was also planned for roughly 140 square feet in the existing parking area. An additional 277 square feet of asphalt, located within the previously graded area, was excavated as well, although it is not included in the new grading area delineated on the map (Figure 2).

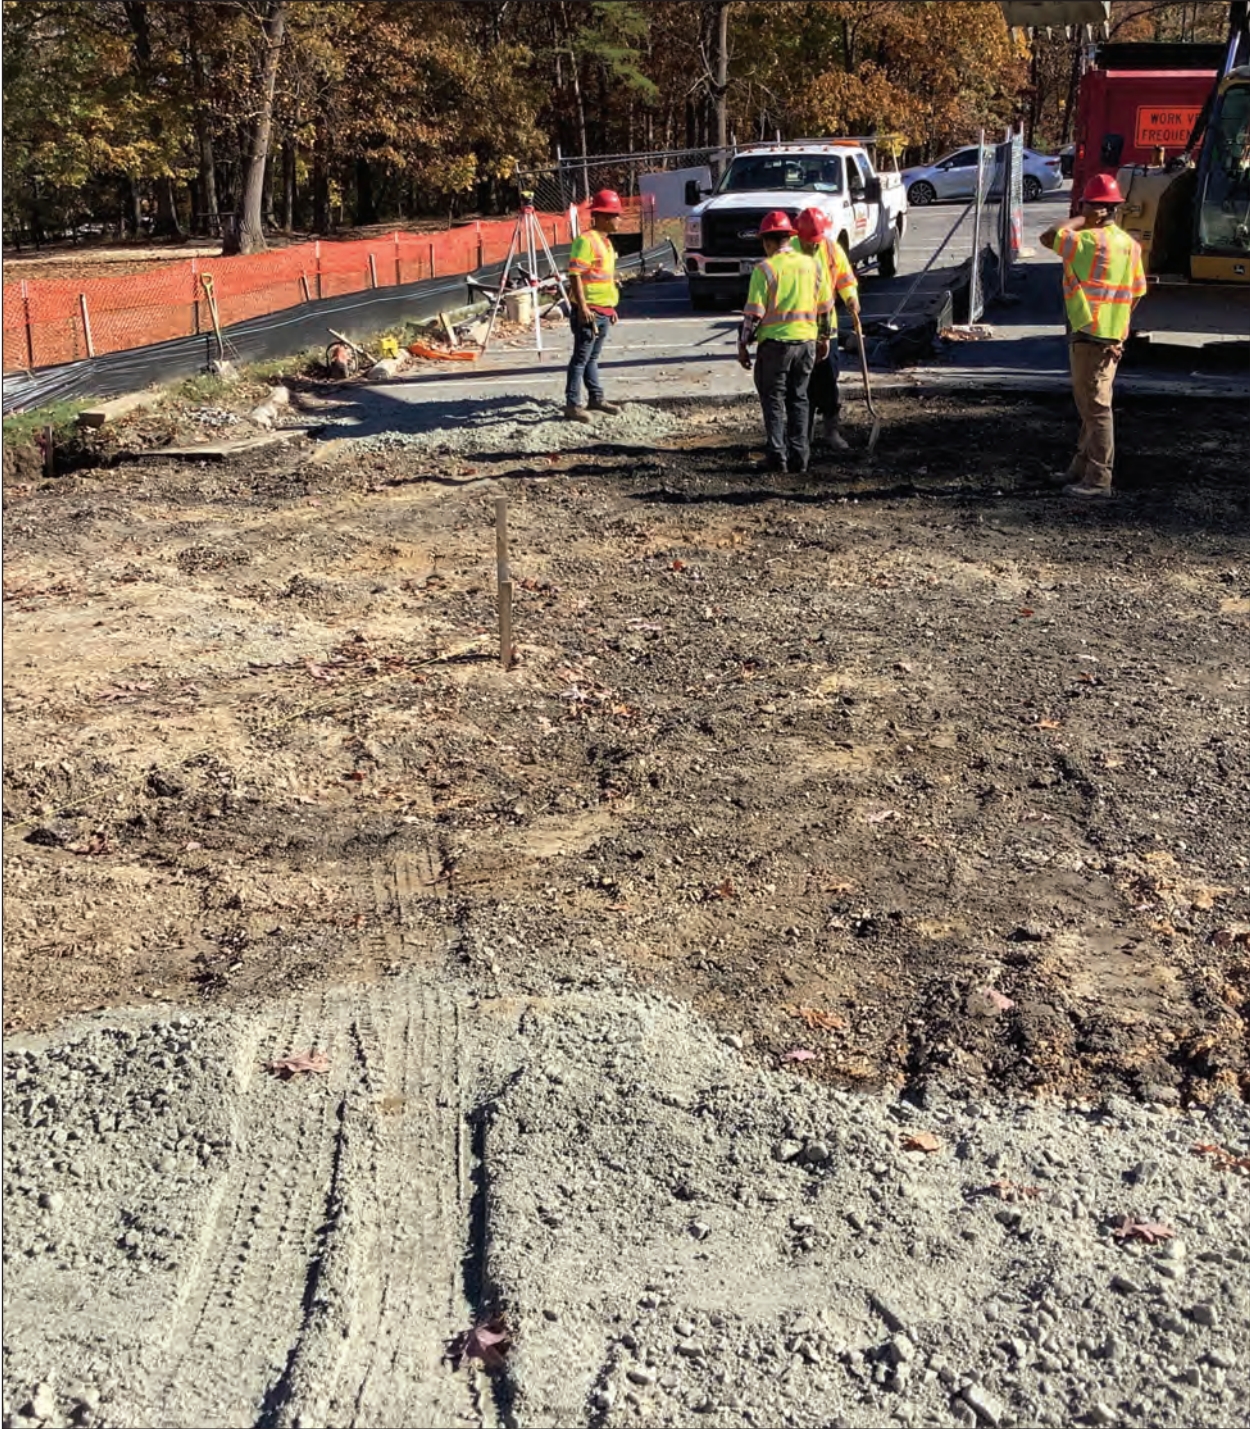
Figure 3.
Road Base after Asphalt Removal, View East

In the new grading area, backhoe excavation along the existing roadway began at the western edge of the project area and continued to the eastern limit until all asphalt was removed. Compact road-base material was exposed. The removal of asphalt and scraping of loose road-base material was sufficient in most places to accomplish the grading required; however, additional grading was necessary within the center of the roadway, where approximately 4 inches of material at most was removed to bring the surface to grade. At no point did the excavation of material encounter undisturbed or historic soil horizons. Excavation occurred entirely within the existing road-base material and the backfill associated with the culvert beneath the road (Figures 3 and 4). No soil profiles were recorded due to the limited extent of excavation. Photographs were taken of the southern, eastern, and western edges of the project area (Figure 5).
